DEPARTMENT OF TRANSPORTATION

Contract #: 04-0120F4Cty: SF/ALA Rte: 80 PM: 13.2/13.9File #: 69.28**WELDING INSPECTION REPORT****Resident Engineer:**Siegenthaler, Peter**Address:** 333 Burma Road**City:** Oakland, CA 94607**Report No:** WIR-018108**Date Inspected:** 12-Nov-2010**Project Name:** SAS Superstructure**OSM Arrival Time:** 700**Prime Contractor:** American Bridge/Fluor Enterprises, a JV**OSM Departure Time:** 1900**Contractor:** Zhenhua Port Machinery Company, Ltd (ZPMC), Changxing Island **Location:** Shanghai, China**CWI Name:** Zhu Feng**CWI Present:** Yes No**Inspected CWI report:** Yes No N/A**Rod Oven in Use:** Yes No N/A**Electrode to specification:** Yes No N/A**Weld Procedures Followed:** Yes No N/A**Qualified Welders:** Yes No N/A**Verified Joint Fit-up:** Yes No N/A**Approved Drawings:** Yes No N/A**Approved WPS:** Yes No N/A**Delayed / Cancelled:** Yes No N/A**Bridge No:** 34-0006**Component:** TOWER Components**Summary of Items Observed:**

TOWER JETTY

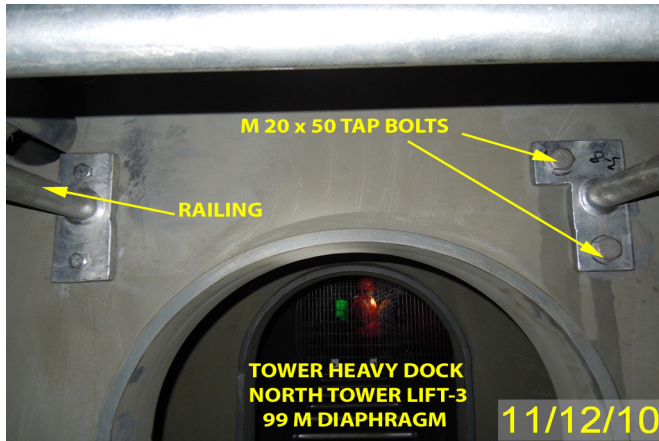
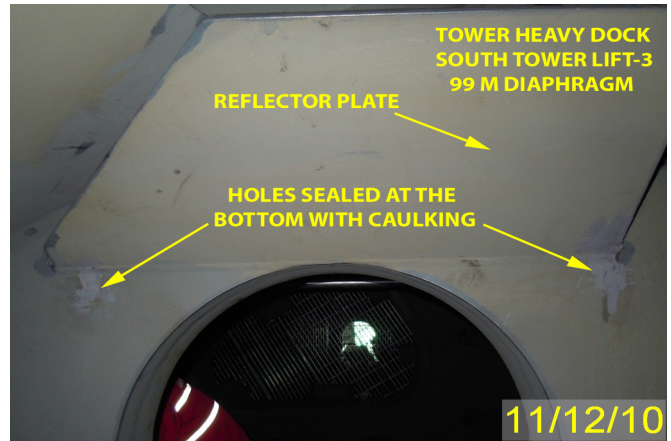
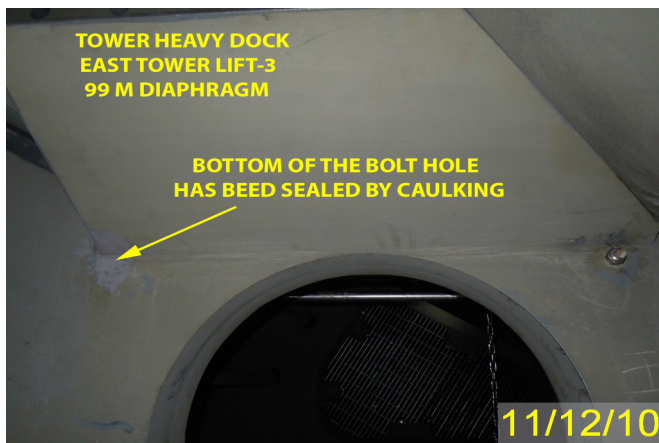
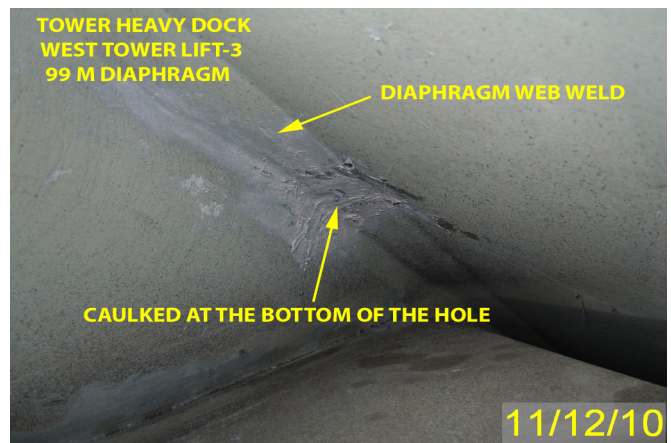
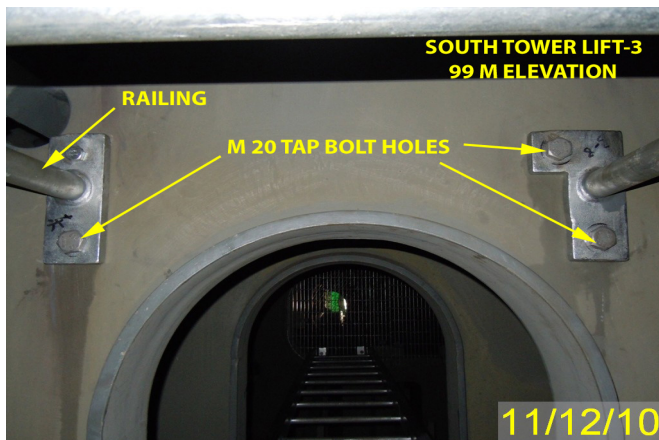
Visual Inspection Testing (VT) for Interference between Railing Bolts and Diaphragm web welds of Lift-3 Tower Shafts at 99 M Elevation

This QA inspector performed VT for tapped holes of railing at 99 M elevation diaphragm on North, East, West and South shafts of lift-3 after ZPMC personnel completed the repair work as per the Changxing Daily dated 11-10-10 issue # 1357R0. This area was previously tested and accepted by ZPMC/ABF Quality Control personnel. The members are identified as TOWER Components. The locations details are as follows:-

1. NORTH shaft – 2 locations
2. WEST shaft – 1 location
3. SOUTH shaft – 3 locations
4. EAST shaft – 2 locations

Note: - The drilled tap holes which were through the thickness of the diaphragm web plate has been caulked from bottom and M 20x50 size bolts used to fill in the tap holes.

For further information see the attached pictures.
